Technical Bulletin #9

CHIPPED TILE

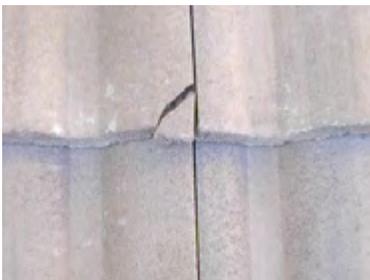
The corners of the tile at the interlock are the thinnest portion of the tile and as such are the most susceptible to damage. When properly installed, there is usually no problem with corner breakage. If the tiles are not properly aligned however, there is the potential for point loading that puts irregular pressure onto the corner, causing it to fracture. This most often happens when the tiles are applied too tightly together. Most tiles are designed to be installed with a 1/16 inch shunt or separation between the tile bodies. If this shunt is not maintained, damage from foot traffic or the expansion and contraction of the roof deck could result.

Debris left in the channel during application could also result in point loading that may break the corners under foot traffic. Sometimes, tiles can have hairline cracks that are not noticed during the original installation but show up as broken corners long afterwards. This is the most common explanation of damage where “no one has ever been on the roof”. Since tiles do not simply break by themselves, a one time repair will typically solve this problem.

Figure 1. Broken cover lock corner

- If the cover lock corner is broken less than three inches, or less than the length of the headlap, and the broken piece is available, it may be possible to repair the corner by proper adhesive application. Using an adhesive specifically formulated for concrete roof tile, follow the manufacturer’s instructions to form a complete bond along the fracture. Take precautions not to allow excess adhesive to bond to the adjacent tile or create water blockage in the under lock.
